CANADIAN FORCES FLIGHT SAFETY INVESTIGATION REPORT (FSIR)

FINAL REPORT

FILE NUMBER: 1010-11305 (DFS 2-4)

AIRCRAFT TYPE: CH 113 Labrador

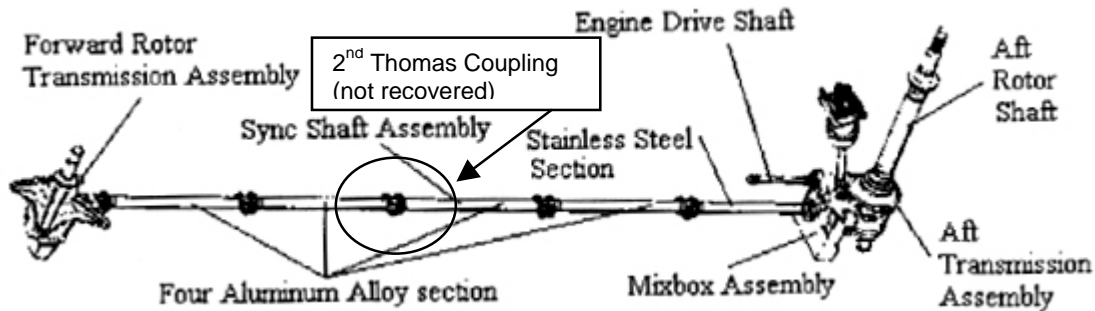
Figure 2: Sync Shaft and Transmission Assemblies

There is a continuous stainless steel firewall between the engines and a stainless steel casing that partially encloses the sync shaft. The section of sync shaft located in this area is made of steel (see Figure 2) for improved fire resistance and it runs lengthways between the engine compartments. However, there is open access between the #5 sync shaft area and the number two engine compartment. The sync shaft rotates at high speed (2562 RPM) when the

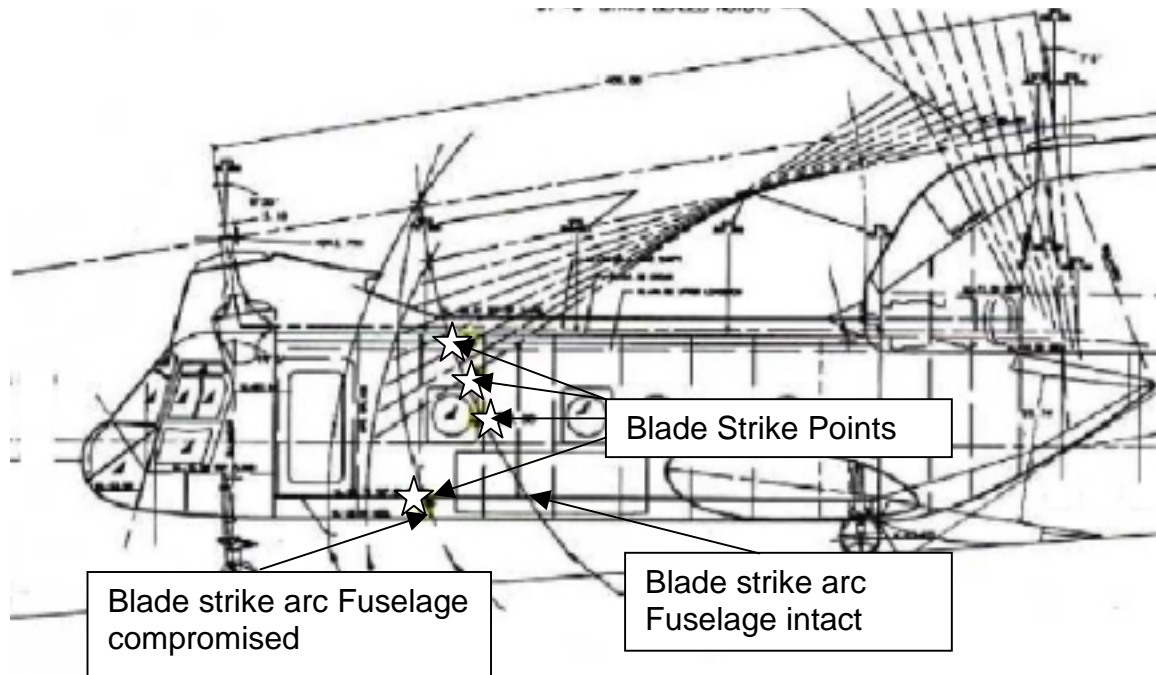
Figure 4: Pylon position and blade arcs compared to fuselage strike positions

The rear pylon and rotor head were found separated from the rest of the aircraft with the blades attached. The mapping of the fuselage cut locations indicated that the first three cuts were made while the rear pylon and aircraft fuselage were in their normal configuration and position. From this evidence, it is concluded the blade to fuselage cut up sequence was initiated with the aircraft fuselage intact. Therefore, the fuselage did not buckle so no substantial deformation to the aircraft had occurred until after the blade to fuselage cutting sequence began and serious fuselage deformation commenced between the third and fourth blade to fuselage cuts.

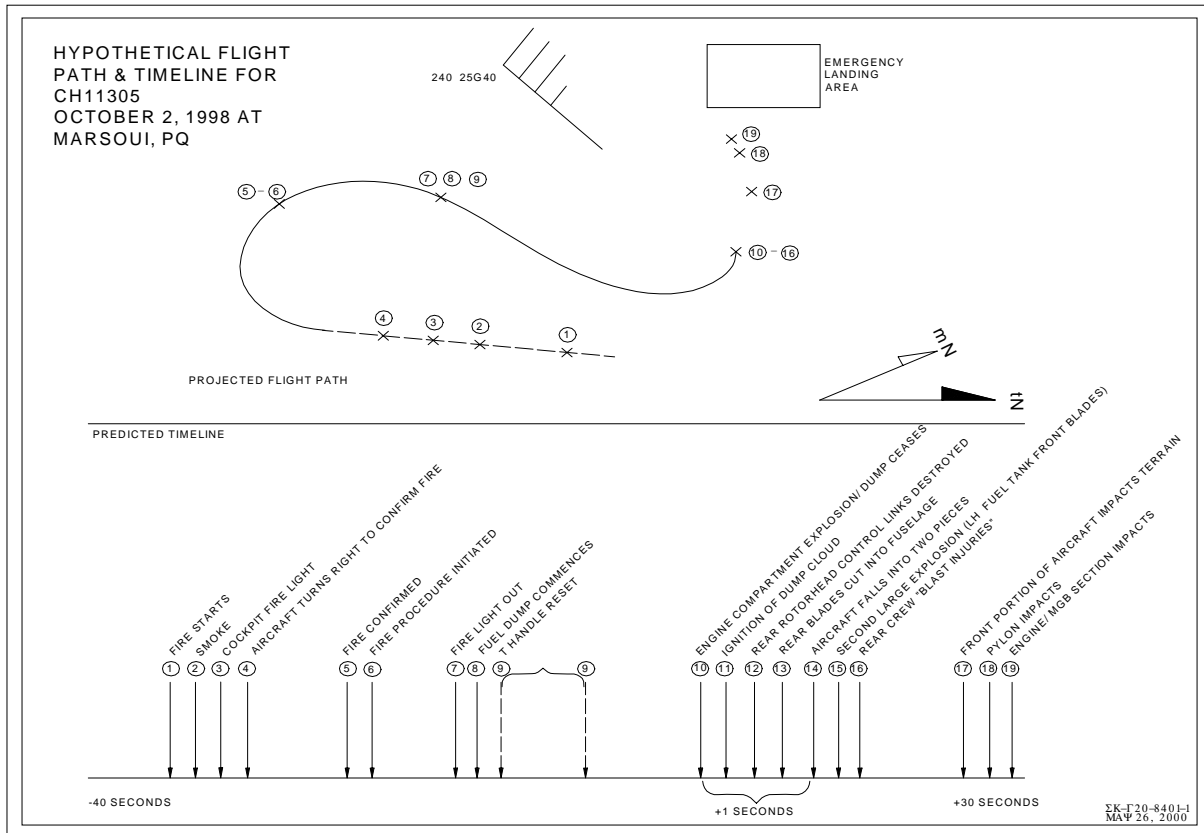
Figure 7: CH11305 Hypothetical Flight Path and Timeline

From the evidence it was determined that the T-handle had been pulled and utilised to activate the fire extinguishers. Also, the evidence indicated that the T-handle was later positioned such that the shutoff valves were in the open position when the aircraft was cut into pieces. Although the exact time for this action could not be determined, it is likely that it was positioned early enough to supply fuel to the engine compartment so that an explosive mixture built up in that area and this would not take a long period of time to occur. As well, this event occurred when the fuel dumping procedure was ongoing, thereby, creating conditions for a large explosion to the rear of the aircraft.

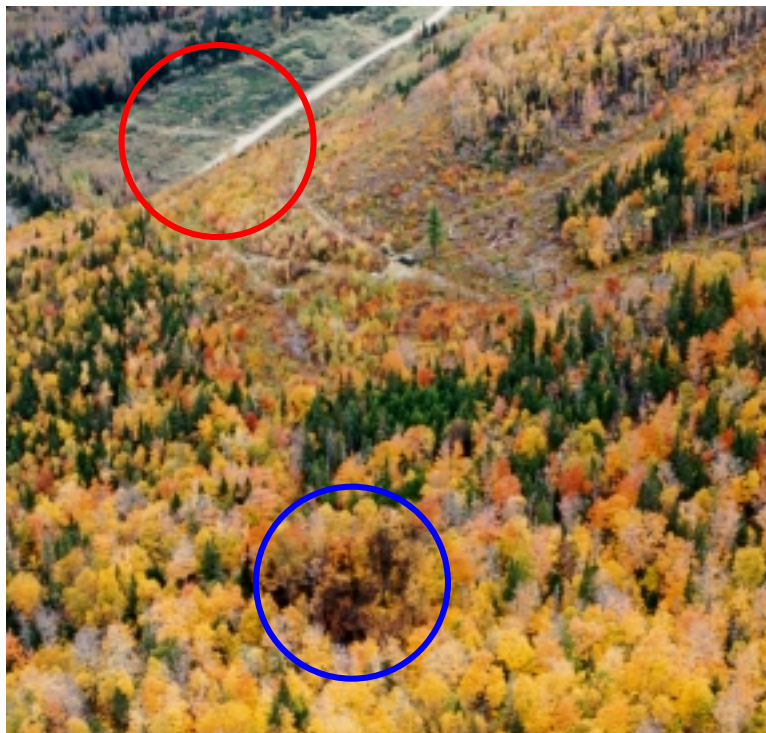
Photo 4- Emergency Landing Zone (Red) and Site 3 - Rear Fuselage Burn Mark (Blue) (Note truck at Upper Recovery Location)// Zone d'atterrissage d'urgence (en rouge) et secteur 3 : preuves de la combustion du fuselage arrière (en bleu) (remarquez le camion dans le secteur supérieur de récupération)

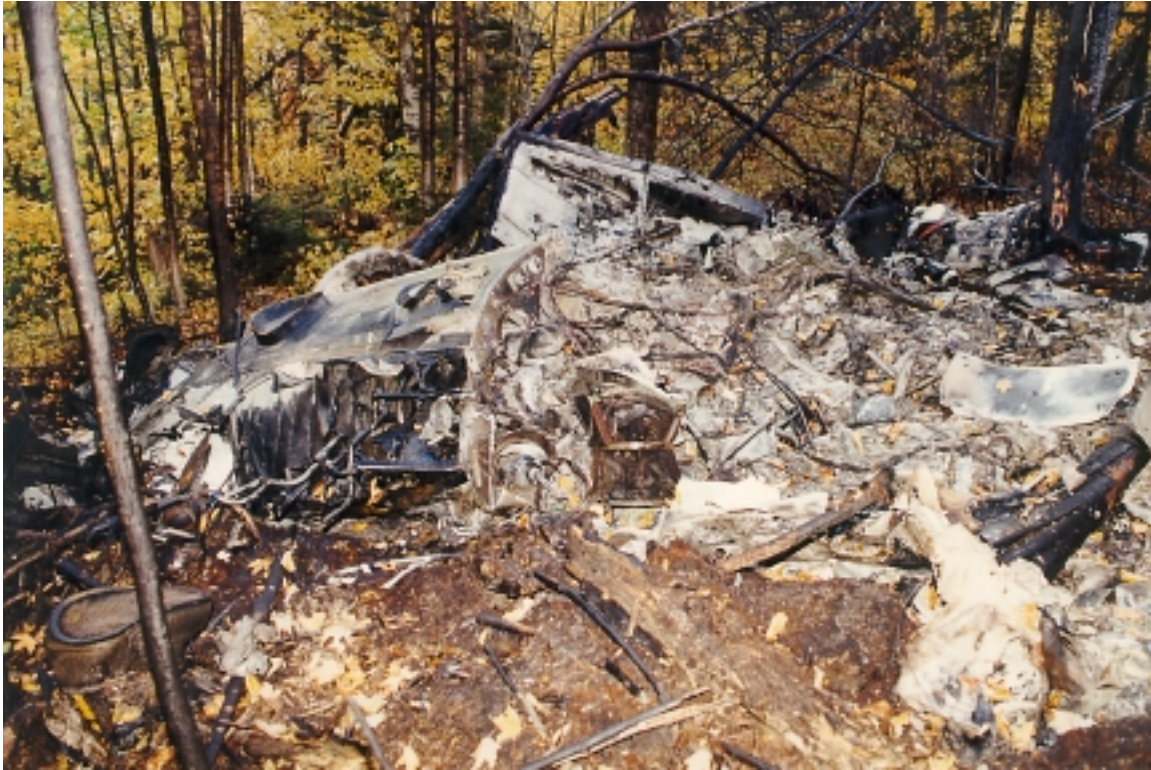
Photo 5 - Site 3 - Aft Fuselage, Engines and MGB// Secteur 3 : fuselage arrière, moteurs et boîte de transmission principale

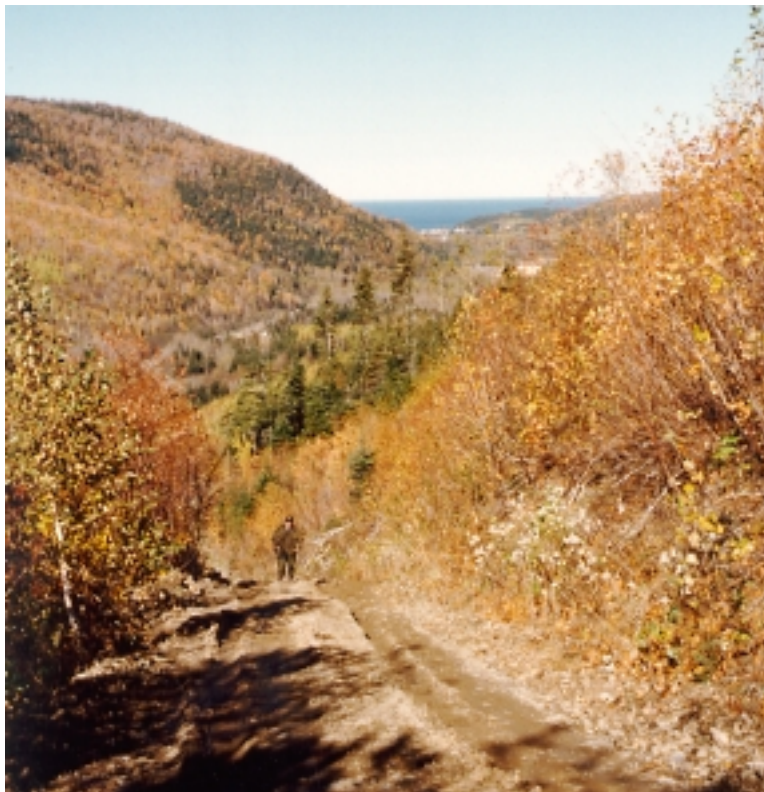
Photo 10 Road to Upper Recovery Location (see photo 4)// Chemin menant au secteur supérieur de récupération des débris (voir la photo 4)

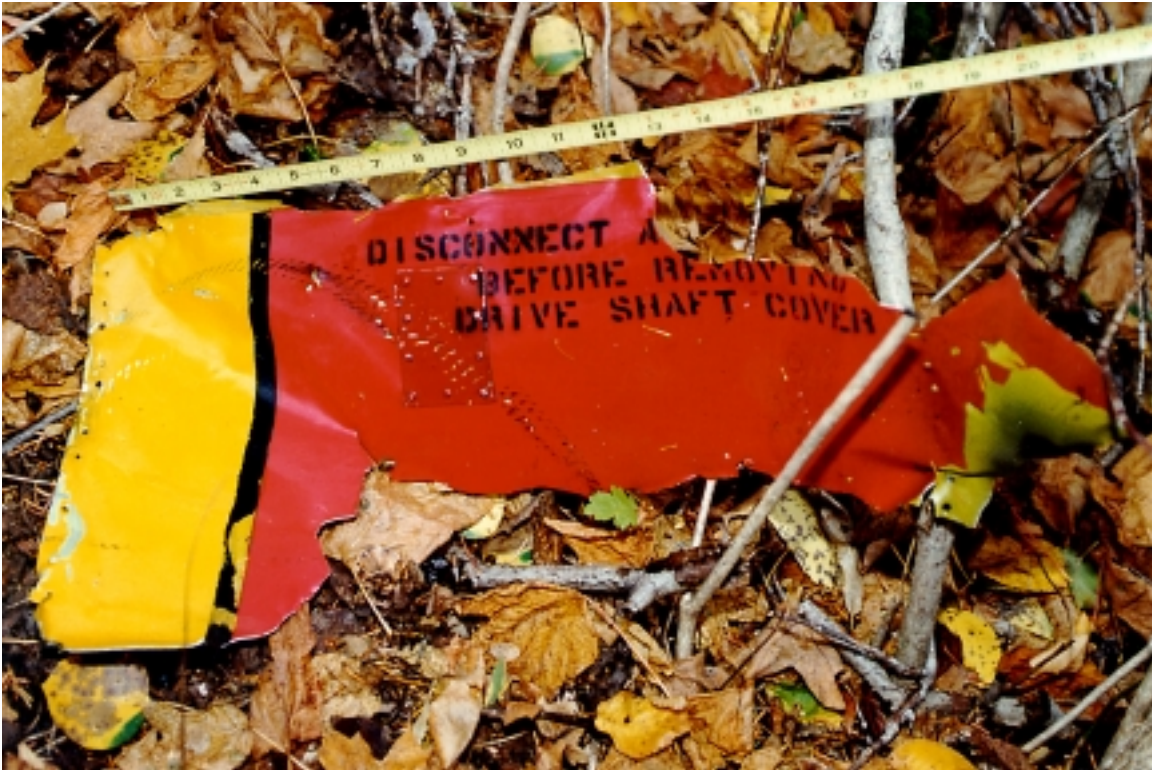
Photo 11 - Debris in Upper Field - Sync Shaft Tunnel Cover// Débris récupérés dans le secteur supérieur : carter du tunnel de l'arbre de synchronisation

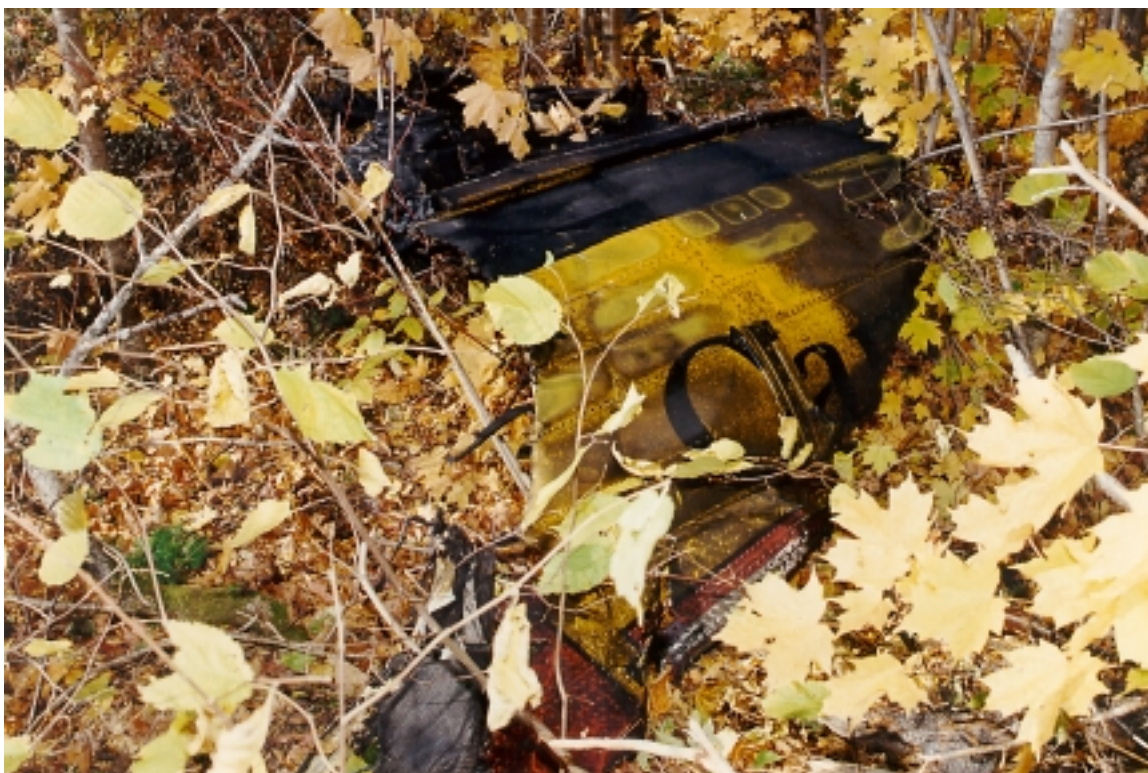
Photo 14 - Debris in Upper Field - Rear fuselage// Débris récupérés dans le secteur supérieur : fuselage arrière

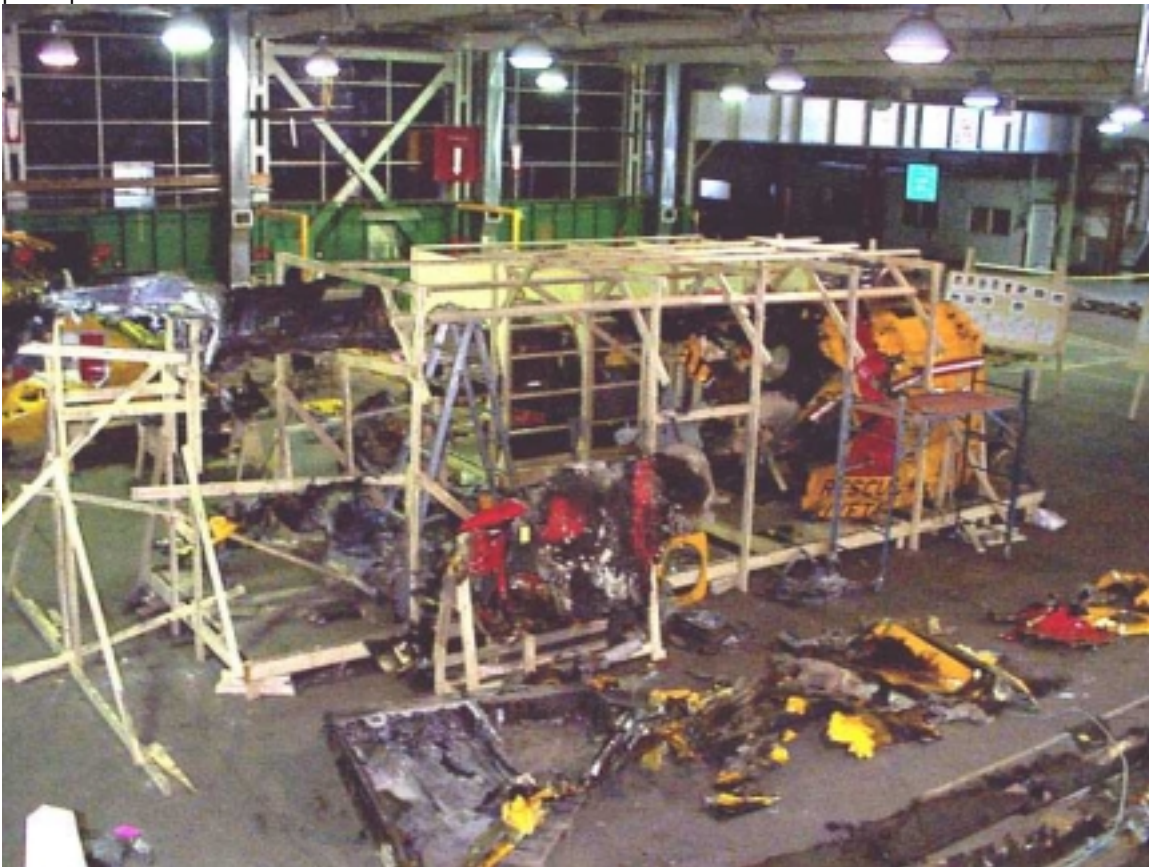
Photo 18 - Rebuild of Ch11305 - Right side// Reconstitution du CH11305 : côté droit

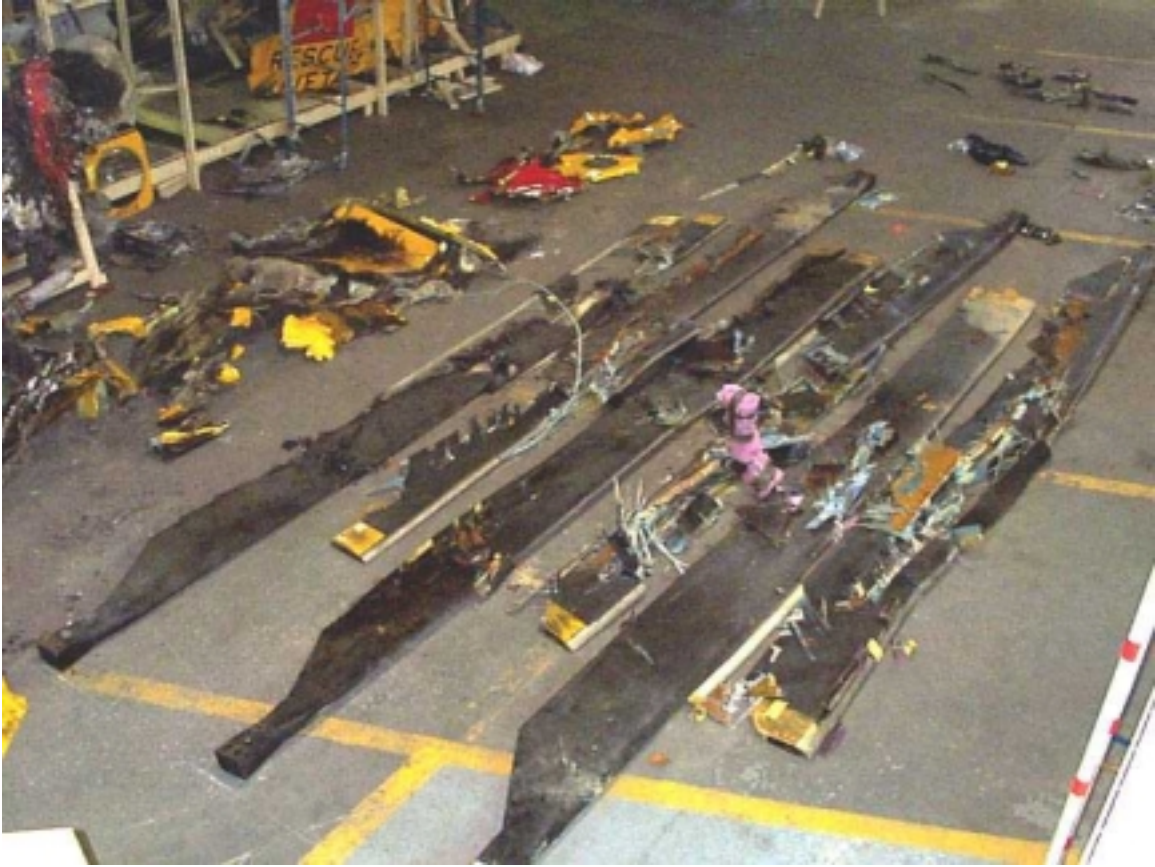
The rotor blades are colour coded green, yellow and red. Examination of the rebuilt rear blades was undertaken at the re-build facility. This showed that the green blade was still attached to the rear pylon, was relatively intact and had no damage related to fuselage contact; however, there was some burn damage and soot deposits on its surface. The yellow blade was also intact and attached to the rear pylon with soot and burn damage; however, scratch mark comparison showed that the yellow blade made the first and third fuselage cuts. Further scratch mark examination showed that the red blade caused the second and fourth strikes. While most of the red blade was attached to the rear pylon, a five foot section had completely separated from the end. The separated section was found at the top of the debris field 1000 meters from the aft pylon wreckage. The severed blade did have some fire and burn damage on the portion still attached to the head but the separated blade section was not burnt. When this particular blade made the second cut into the fuselage, it struck the 2nd Thomas coupling. This coupling is a heavy piece of structure used to connect sections of the sync shaft. Despite a specific search for the component, it was not recovered (see Figure 2). According to the Boeing Vertol representative, when blades struck the coupling in previous accidents, the coupling was rarely found and when it was recovered, it was usually a substantial distance from the rest of the aircraft wreckage. It is likely this occurred to the 2nd Thomas coupling from CH11305 and the coupling was not recovered due to the difficult terrain of the crash scene. The contact between the blade and coupling would have caused a great deal of damage to the blade, literally shattering the fibreglass structure. Consequently, during the fourth strike (the second for this blade) the last five feet of the blade was thrown clear of the wreckage as the deep cut through the substantial structure at the bottom of the aircraft fuselage was made (Photo 26). With no burn damage evident on the separated blade fragmented, the burn damage on the red blade occurred after the in-flight break up. The burn damage on the red blade is similar to the burn damage observed on the other blades on the rear rotor. These facts lead to the conclusion that the majority of the burn damage on these blades occurred after the blade to fuselage contact.

Photo 19 - Rebuild of Rotor Blades// Reconstitution des pales de rotor

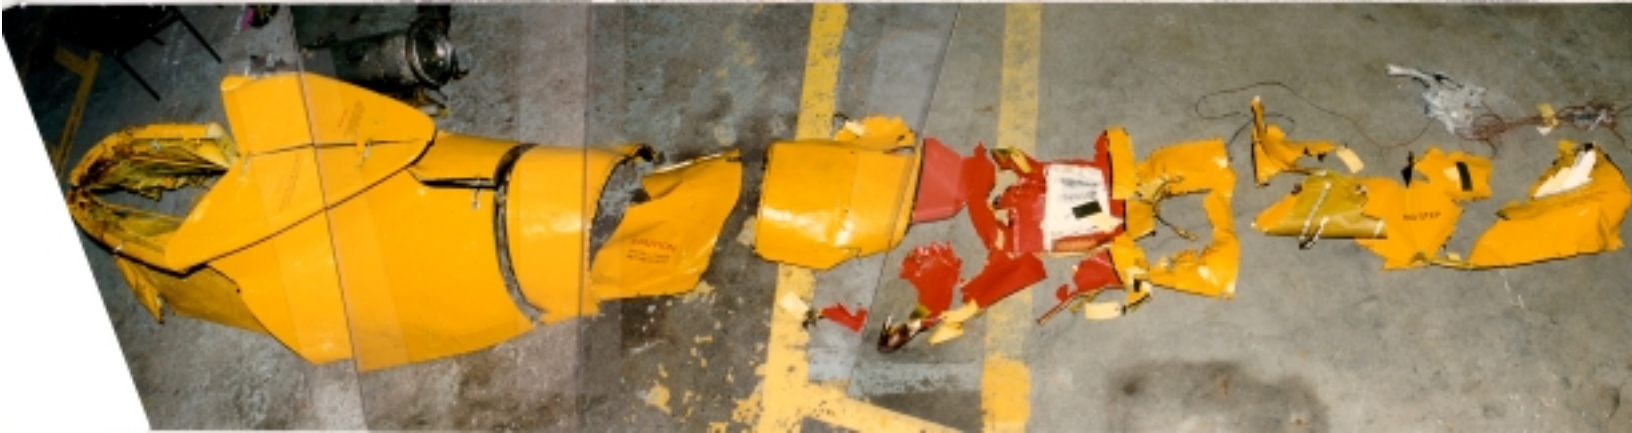
There was little fire damage evident forward of FS 160; however, the tunnel cover down the upper back of the aircraft had soot deposits on the right inside portion as far forward as FS 190 (Photos 27-28). The tunnel cover was cut into many small pieces which were found in the upper debris field. None of the tunnel cover aft of FS 350 was recovered and most of the sync shaft between the 3rd and 4th Thomas couplings was not recovered; however, each of the recovered couplings displayed heat damage and a small amount of melted shaft

Photo 27 - Sync Shaft Tunnel Cover Re-build (exterior)// Reconstitution du carter du tunnel de l'arbre de synchronisation (extérieur)

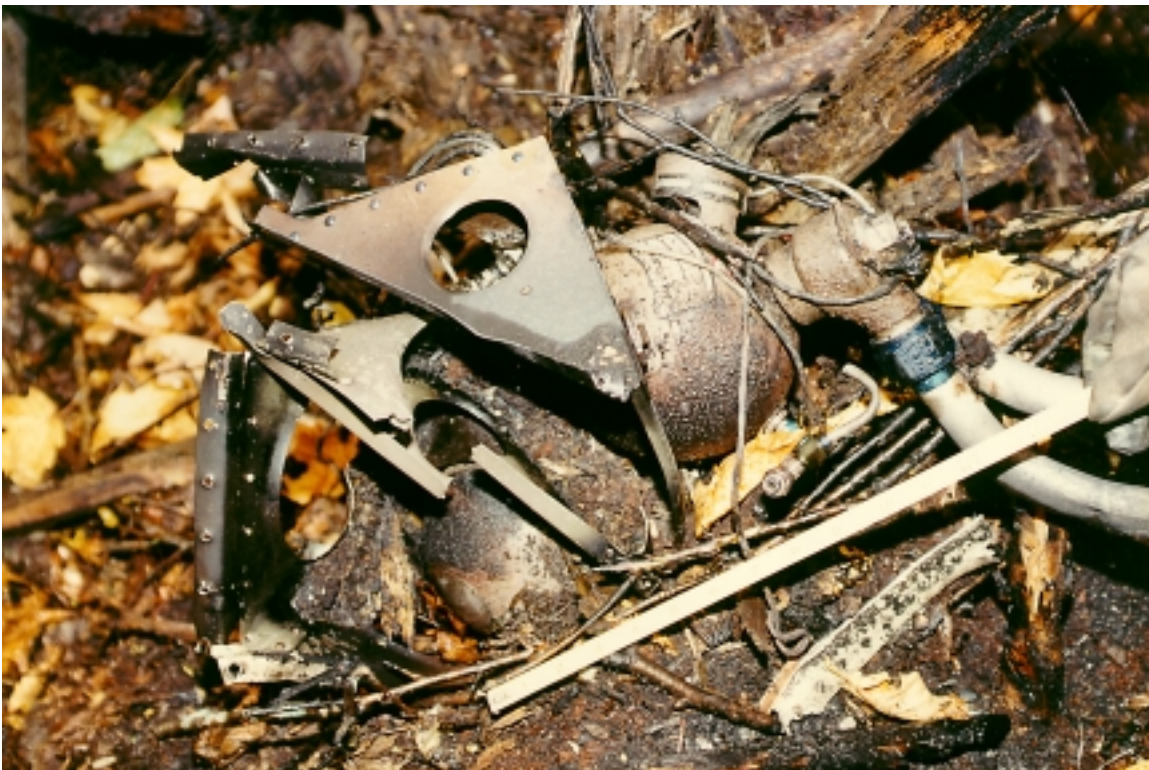
Laboratory (QETE) examination of the fire extinguishing system components from the aircraft revealed that one cartridge in each of the two fire bottles had been fired electrically, both directing agent into the number two engine (Photo 33). None of the other three cartridges of the system were fired, giving the investigation team confidence that the fired cartridges were activated by the crew using the T-handle. Significantly, the oil shutoff valve for the number two engine in the aft pylon, was found in the full open position. The fuel shutoff valve in the right (number two engine) stub wing tank was badly destroyed by fire and no position information could be determined. The number two T-handle was found in the "in" position but was broken and was found, on scene, in contact with a piece of wood. There were no witness marks on the shaft of the T-handle assembly to help determine its position at the time of impact.

Photo 33 - Fire Extinguisher Bottles// Extincteurs

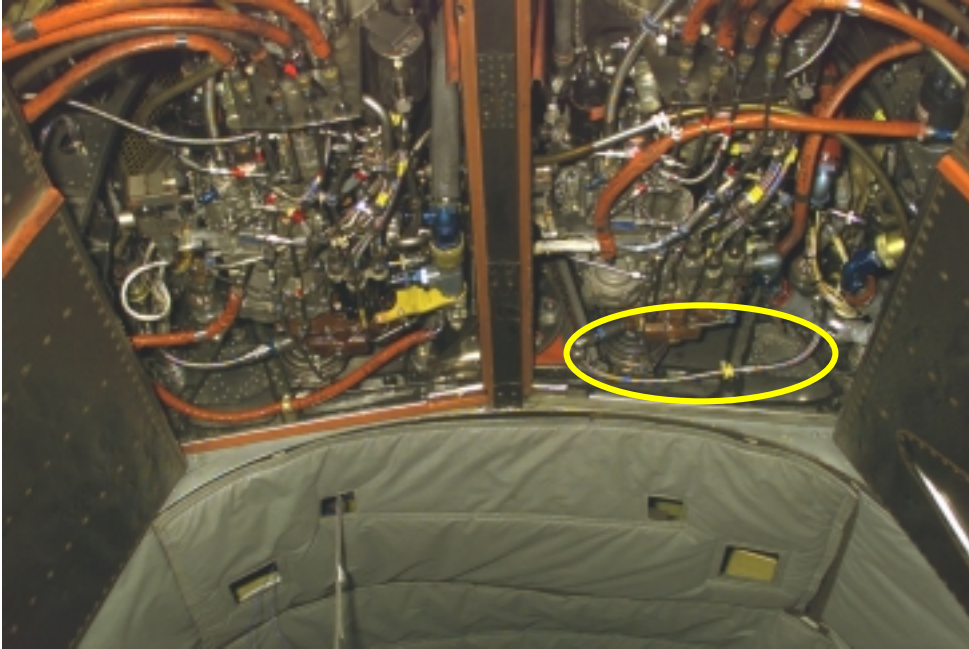
Photo 36 - Normal CH113 Engine Configuration looking from rear ramp forward and up (#2 Engine on right)(Main Fuel Supply Line circled) // Configuration normale d'un moteur de CH113 depuis la rampe arrière, en position avant et relevée (moteur numéro 2 à droite) (la conduite principale d'alimentation en carburant est encerclée)

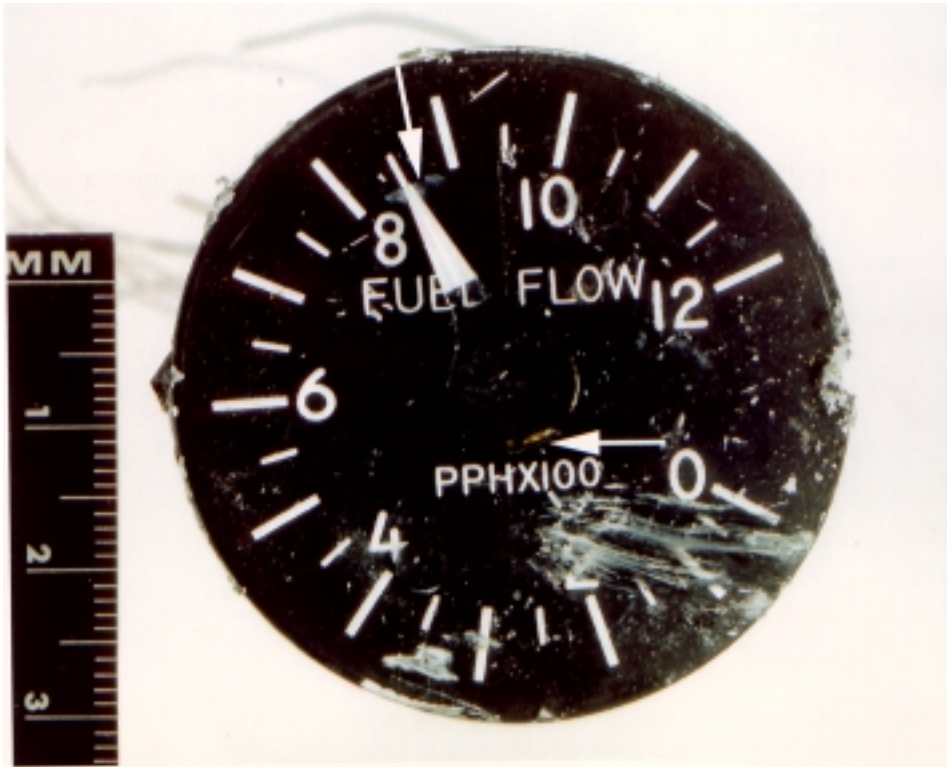
In support of this conclusion, the number two engine fuel flow indicator examination conducted by QETE showed that a mark on the gauge and the pointer itself, which stops when power is interrupted, indicated a fuel flow of 850 pounds per hour (Photo 38). A trial on a CH113 was conducted on an open main fuel supply line and with the boost pumps on, that showed the amount of fuel supplied to the engine would be between 1100 and 1200 pounds per hour. The discrepancy between the indicated 850 and the trial results of 11-1200 could be accounted for by the earlier conclusion that when electrical power was cut to the number two engine, there was a leaking fuel supply line that had been damaged by the original fire (Photo 37). The trial fuel system conditions were used because, if the #2 T-handle on CH11305 was reset with the fuel boost pumps selected on, fuel would flow into the compartment at a certain rate. Both of the #2 "Press to Set" switches on the Fuel Control Panel were found "Pressed IN" indicating that the boost pumps were "ON" if the switch position was not changed by the forces acting on the aircraft during the in-flight break up and ground contact. The trial data matched these projected switch conditions and the measured fuel flow was close to the actual marks on the fuel flow gauge from CH11305. From these points it was projected that if there was a fuel leak in that area of the engine there would have been fuel available for a fire. Furthermore, the damage to the main fuel supply line would have allowed substantial amounts of fuel to enter the #2 engine compartment if the T-handle was reset with the boost pumps ON. An assessment of the reliability of the fuel flow indicator marks was considered "dependable" but not infallible. Similarly, the Fuel Control Panel switch positions are not considered completely reliable due to the multitude of forces acting on the aircraft and in the cockpit during the aircraft break up.

Photo 38 - Number 2 Engine Fuel Flow Indicator // Indicateur de débit carburant du moteur numéro 2

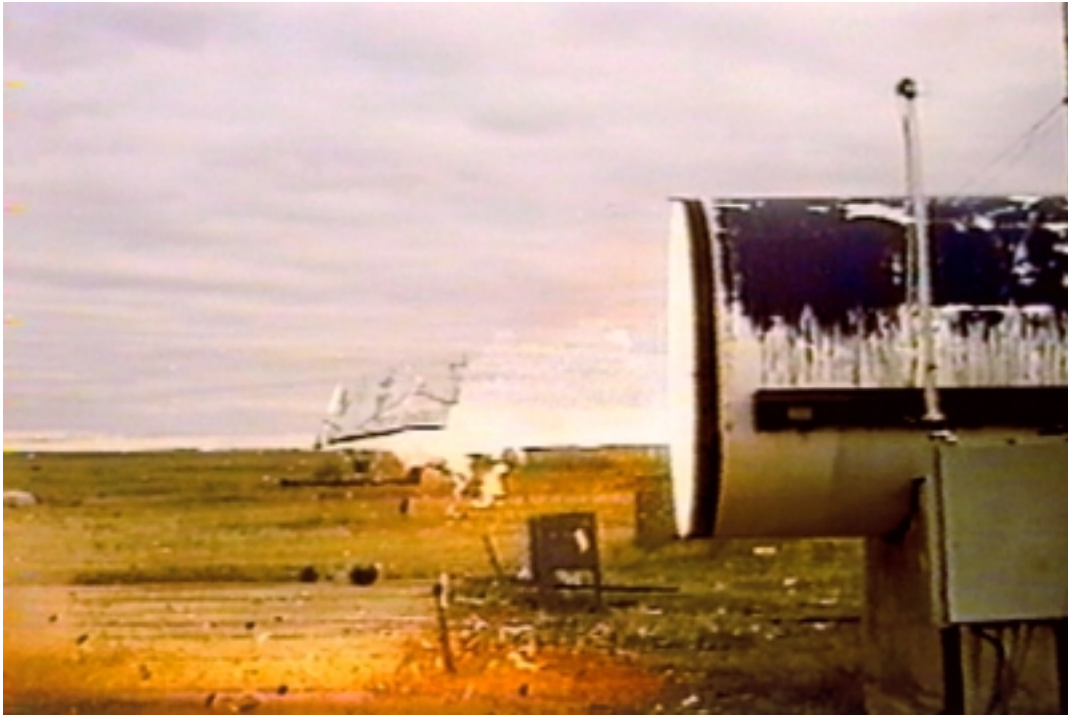
Photo 44 - DRES Engine Door Blast Experiment - Note simulated blast door exiting structure // Expérience du CRDS portant sur l'ouverture de la porte d'accès au moteur lors d'une explosion; remarquez la reproduction de la porte qui est projetée hors de la structure

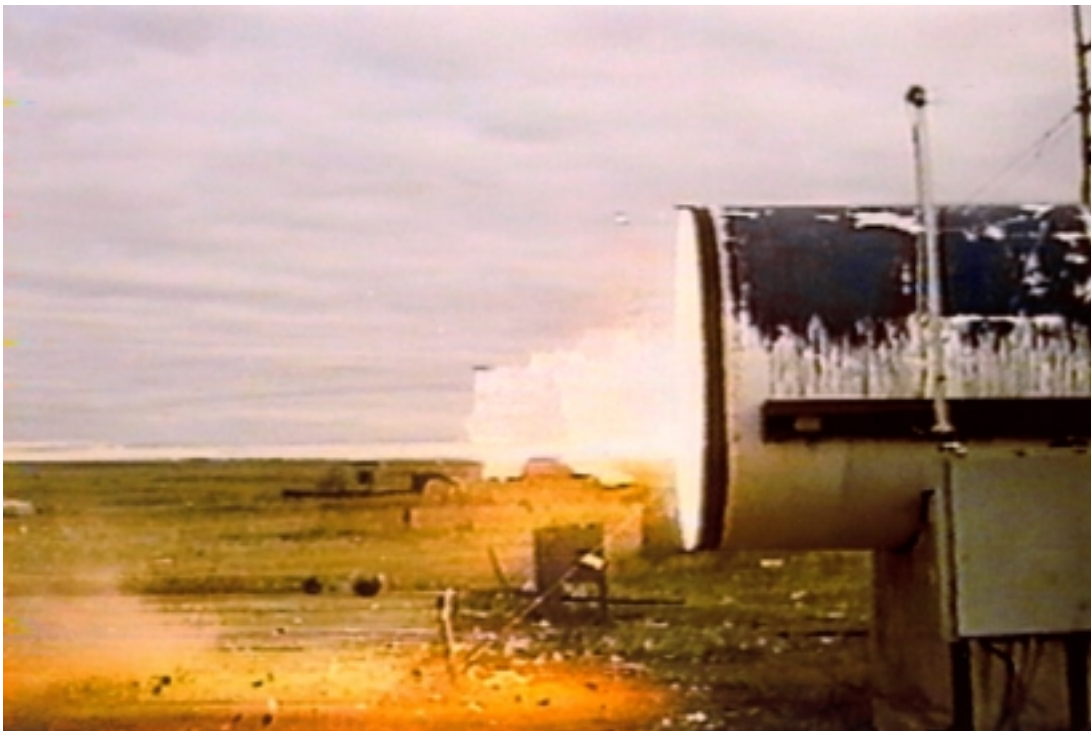
Photo 45 - DRES Engine Door Blast Experiment - Note flame emerge from structure (possible ignition source for fuels exterior of structure through vents) // Expérience du CRDS portant sur l'ouverture de la porte d'accès au moteur lors d'une explosion; remarquez la flamme qui sort de la structure (source d'allumage possible du carburant rejeté à l'extérieur de la structure par des mises à l'air libre)

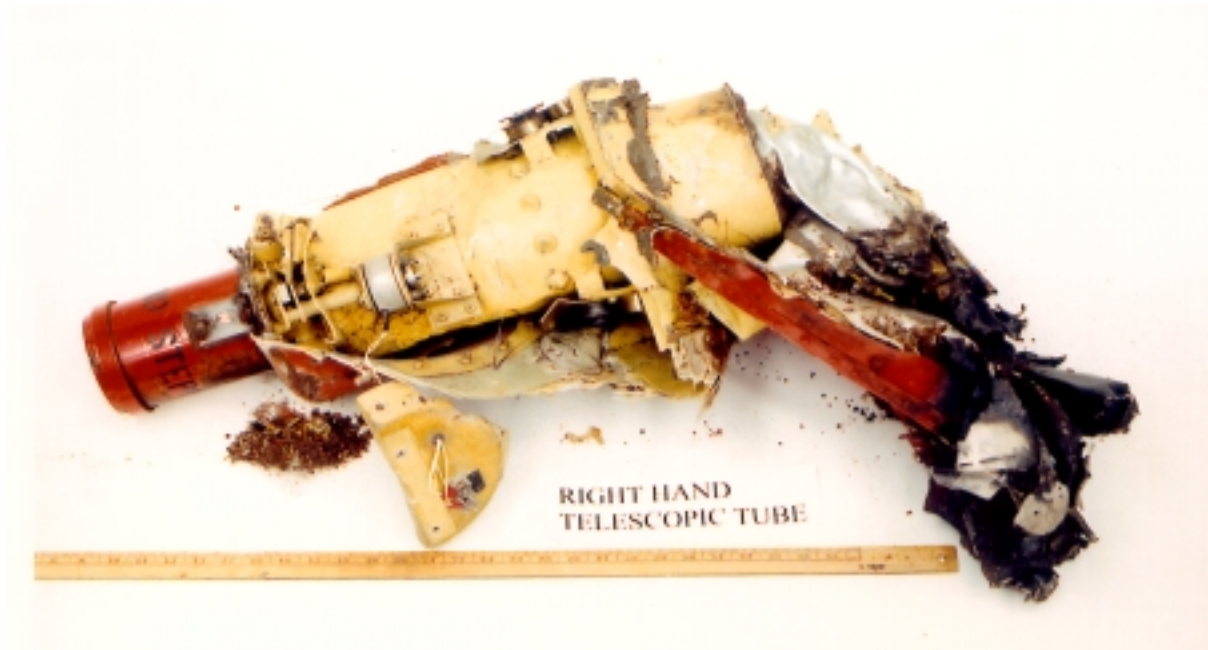
The #2 engine compartment fire and engine door blast were located on the rear right of the aircraft. The fuel dump tube on the right side of the aircraft did not deploy, thereby increasing the likelihood of fuel to fuselage contamination in that area. The engine door blast experiment from DRES showed an ignition source for the fuel dump cloud in the form of a quick, yet long flame that extended out of the compartment during the blast (ref para 2.6.7 and Photo 45). This series of facts combine to locate an exterior event to the rear and right of CH11305. This links well with the injury pattern on one crew member indicating that he was looking rear and right of the aircraft. As well, the visual signature of

Photo 46 - Right Hand Fuel Dump Tube (retracted and confirmed)// Tube droit du vide-vite (rentré et confirmé)

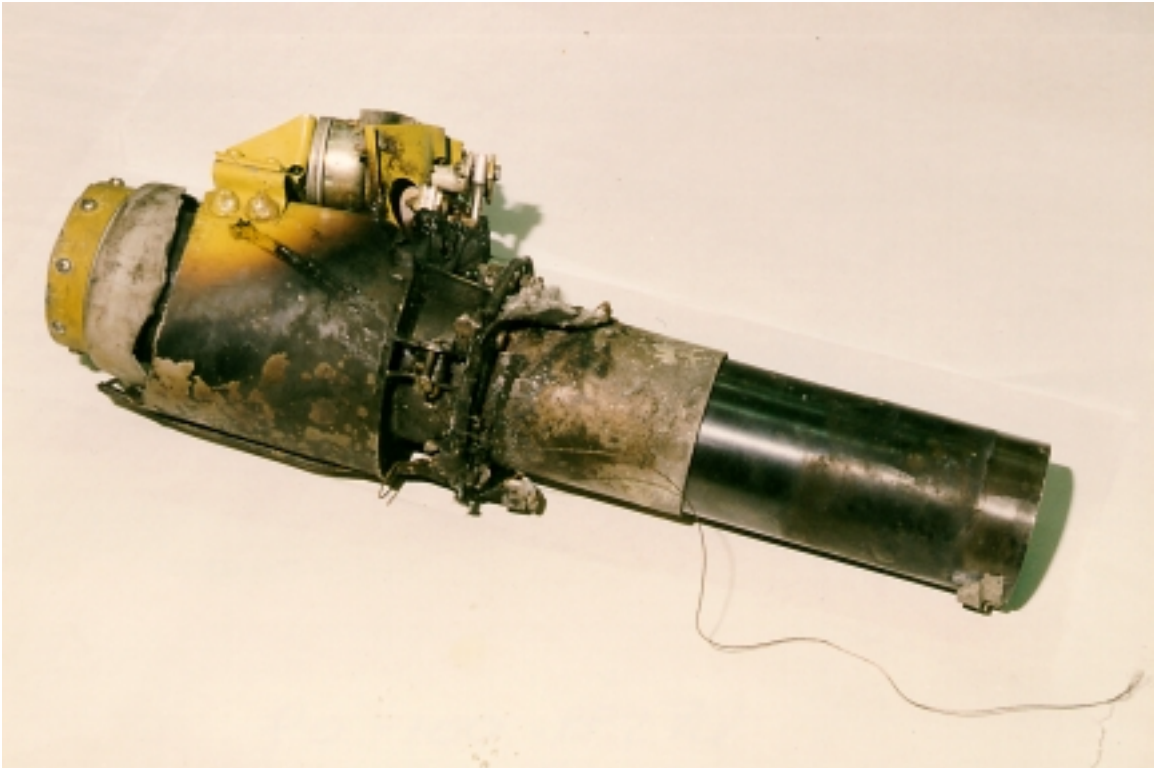
Photo 48 - Left Hand Dump Tube (extended and confirmed)// Tube gauche du vide-vite (sorti et confirmé)

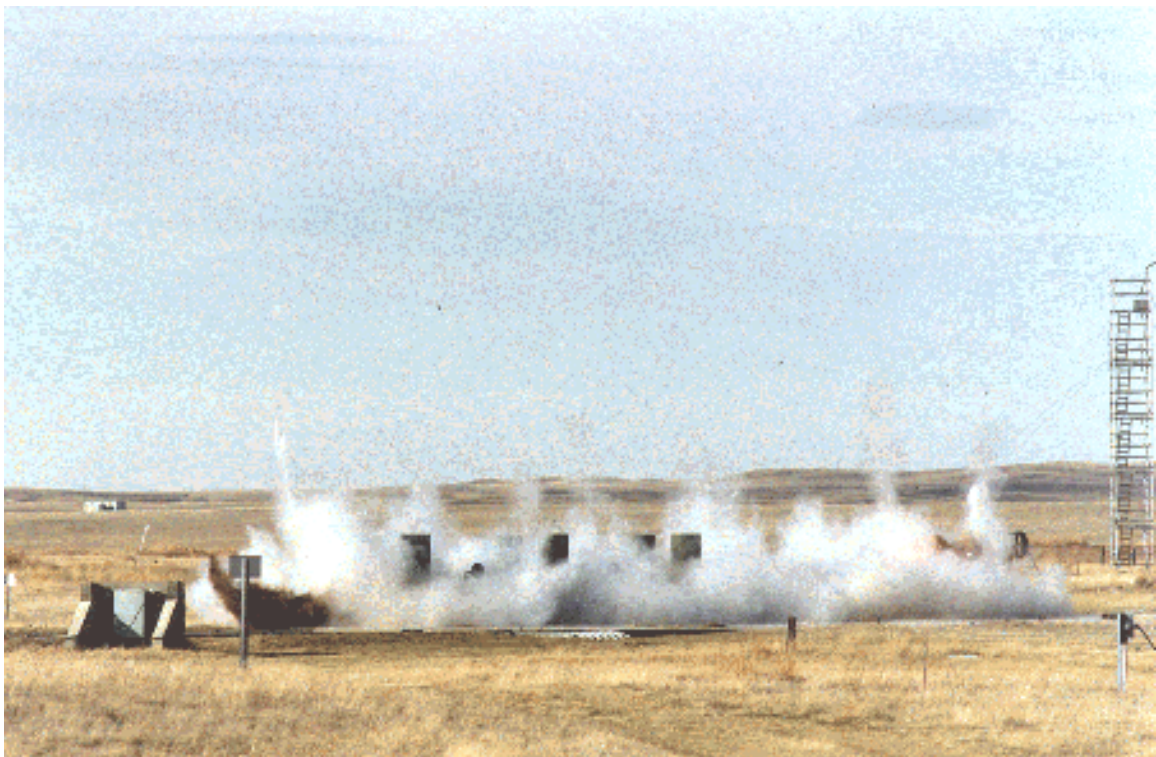
On the basis of the fuel dump evidence and imagery, DRES began another series of experiments to reproduce the dumped fuel vapour cloud and ignite the cloud (Photo 51). An approximation of the cloud was replicated that was easily ignited and produced a large "gasoline like" fireball (Photos 52-53). These experiments could not reproduce the flight conditions that the accident aircraft encountered but the physical characteristics of the fireball they did produce were measured. These measurements did not show any appreciable blast wave produced by the fireball, but a pocket of high temperature, low density gas remained in the area for up to 30 seconds. The term for the type of event that was reproduced in the experiment is an ignition (slow burn), rather than a deflagration (fast burn) or detonation (explosion). The results of this experiment visually matched the description of the eyewitnesses. Of note, one of the factors that may lead to elevated pressures with open air blasts occurs when rapid turbulent mixing exists in the fuel air cloud. These conditions are very difficult to experimentally reproduce. However, the meteorological atmospheric conditions, rotor downwash, topography-induced turbulence and emergency manoeuvring of the accident aircraft may have produced this condition.

Photo 51 - DRES Experiment re-producing fuel dump cloud// Expérience du CRDS reproduisant le nuage de carburant résultant d'un largage

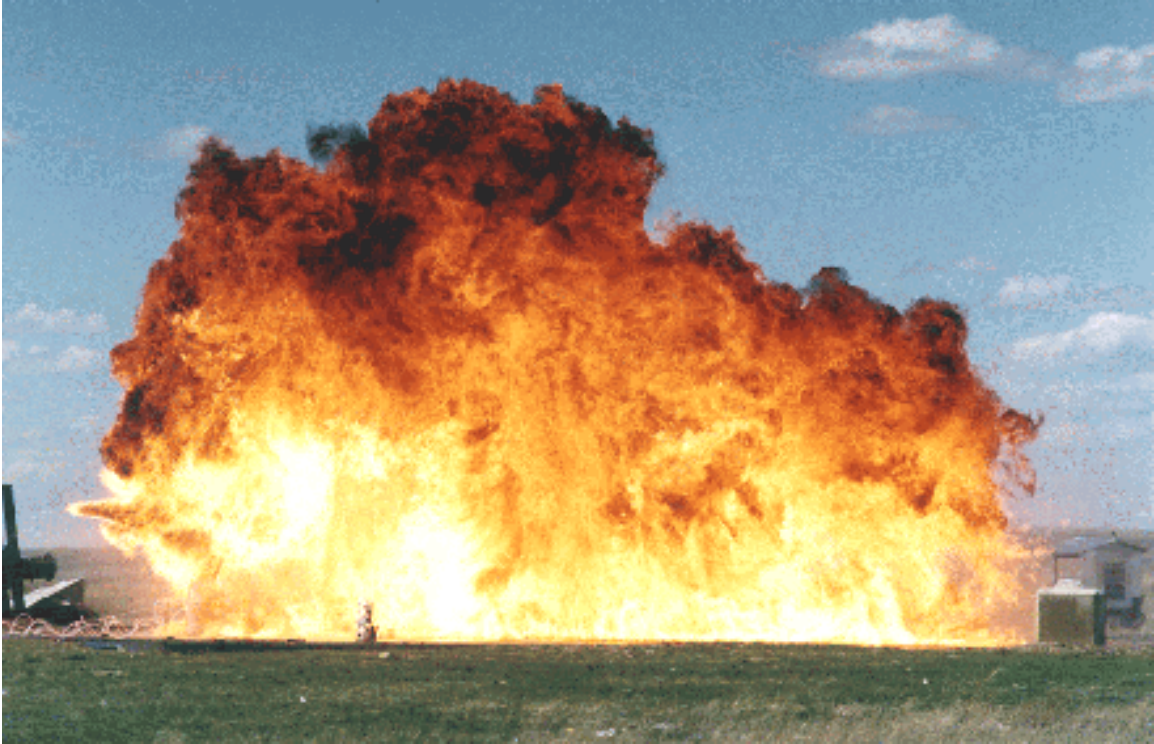
Photo 52 - DRES Experiment igniting simulated fuel dump cloud// – Expérience du CRDS visant à enflammer le nuage de carburant simulé à la suite d'un largage

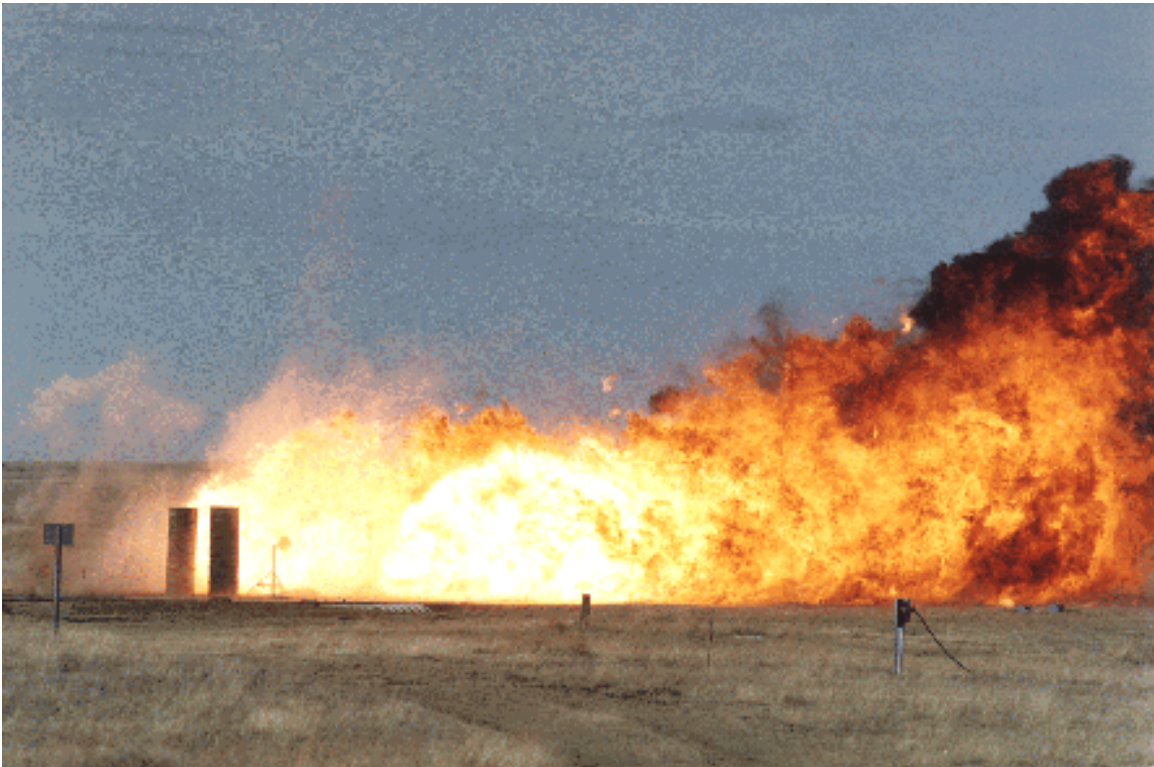
Photo 53 - DRES Experiment igniting simulated fuel dump cloud (under different conditions)// Expérience du CRDS visant à enflammer le nuage de carburant simulé à la suite d'un largage (dans des conditions différentes)

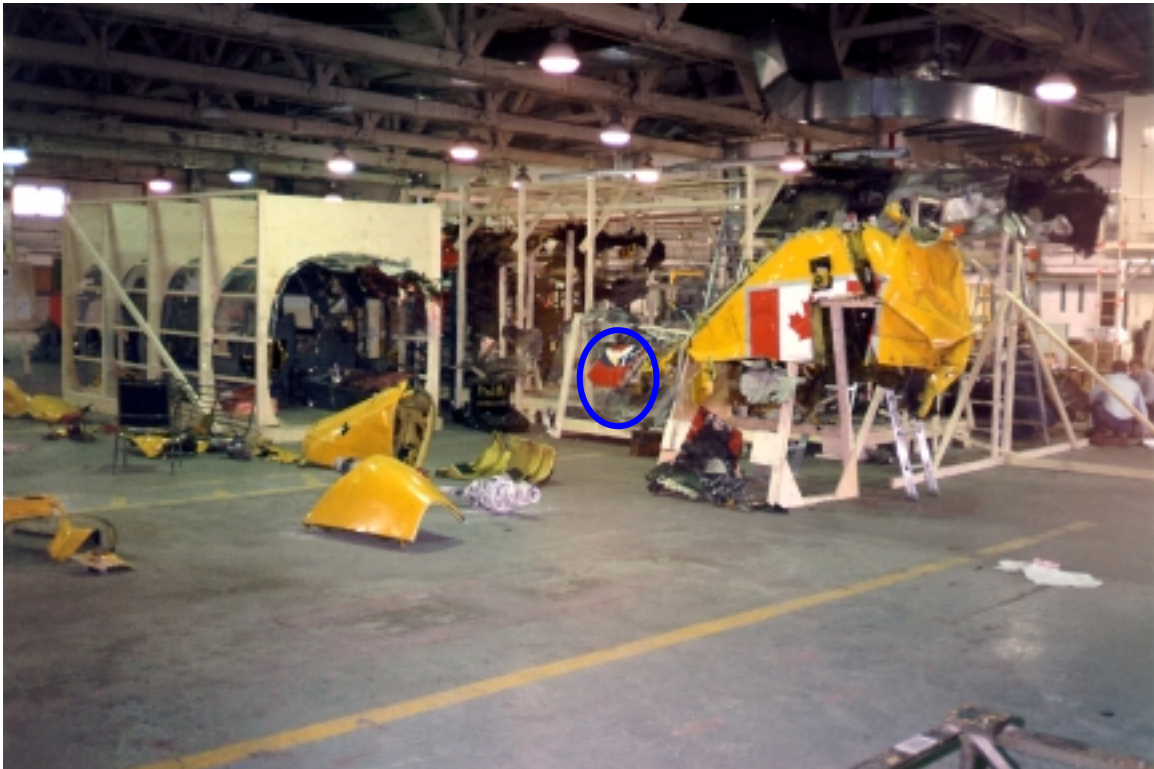
Photo 57 - Rebuild Facility showing Left Stub Wing Fuel Tank Section (circled)// Installation où l'on a procédé à la reconstitution et réservoir de carburant du moignon d'aile gauche (encerclé)
